Field Quality Analysis as a Tool to Monitor Magnet Production*

R. Gupta¹, M. Anerella, J. Cozzolino, D. Fisher, A. Ghosh, A. Jain,
W. Sampson, J. Schmalzle, P. Thompson, P. Wanderer, E. Willen
Brookhaven National Laboratory, Upton, NY 11973, USA

Abstract—Field harmonics offer a powerful tool to examine the mechanical structure of accelerator magnets. A large deviation from the nominal values suggests a mechanical defect. Magnets with such defects are likely to have a poor quench performance. Similarly, a trend suggests a wear in tooling or a gradual change in the magnet assembly or in the size of a component. This paper presents the use of the field quality as a tool to monitor the magnet production of the Relativistic Heavy Ion Collider (RHIC). Several examples are briefly described. Field quality analysis can also rule out a suspected geometric error if it can not be supported by the symmetry and the magnitude of the measured harmonics.

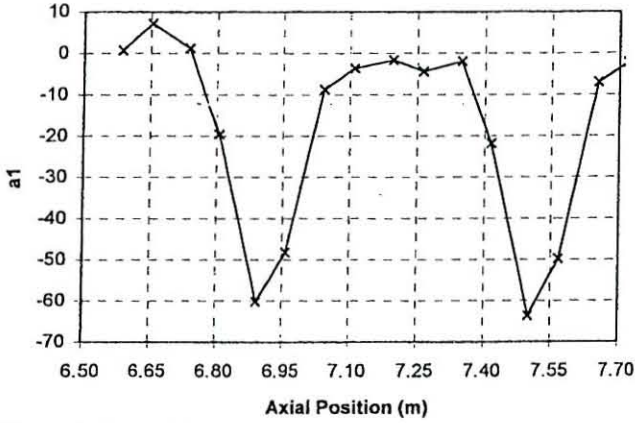
Figure 1: The axial variation in the skew quadrupole harmonic in RHIC 80 mm aperture dipole DRG189 in the suspected region.

The magnet was transported from the vendor to the Laboratory for more measurements and analysis. The measurements were repeated with another one meter long rotating coil with smaller axial steps, to derive the axial profile of field harmonics with better resolution. Fig. 1 shows the axial variation in the skew quadrupole harmonic derived from such a procedure based on the 0.15 m step size. The sextupole harmonic was also measured directly with a Hall probe array (effective length ~1 mm) to verify the procedure used.

The RHIC magnets use two types of 0.15 m long RX630 insulators between the coil and the yoke. Those used in the body have a pole to compress the coils and those used in the ends have no pole. Based on Fig.1 and based on the parts used in magnets, it was postulated that end-type of pole spacers may have been inadvertently used in two places in the body of the magnet. Furthermore, calculations showed that with missing compression (and therefore a change in the effective turn thickness), the turns have moved upward symmetrically towards the vertical axis with a maximum displacement of 1.7 mm. This was consistent with the expected uncompressed coil size. The magnet was partly disassembled to verify this scenario and upon inspection it was indeed found to be the case. A magnet with such a large discontinuity in the superconducting coil is expected to have a poor quench performance, and was not accepted for RHIC. A similar error was discovered in another magnet, DRG226.

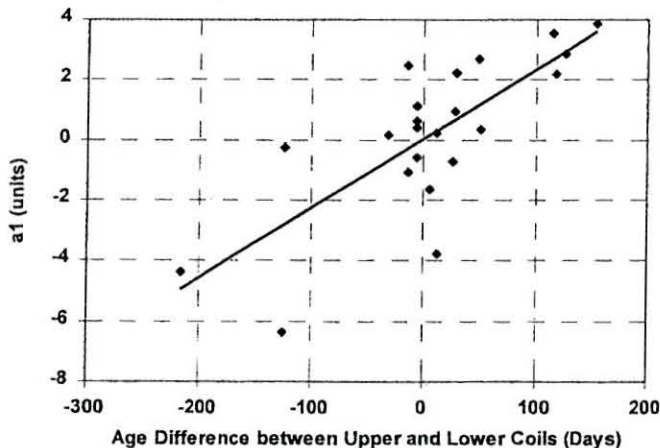
Figure 4: A correlation plot with a least square fit between the skew quadrupole and the age (from curing to collaring) difference between the upper and lower coils in 100 mm aperture RHIC insertion dipoles.

During the warm magnetic measurements of RHIC 100 mm aperture insertion dipoles, it was found that the RMS variation in the skew quadrupole harmonic (~ 2.5 units) was larger than the value obtained in 80 mm aperture arc dipoles (1.6 units). Since the two are built using similar design and construction techniques, one should expect a similar or smaller value in insertion dipoles due to their larger aperture. This large RMS was later traced to the storage of the coils for greatly varying periods of time prior to collaring. This allowed the coil azimuthal size to grow with time. The two coils in a particular magnet were matched in azimuthal size to 0.025 mm based on the size measured just after curing. In Fig. 4, we make a correlation plot between the difference in age (from coil curing to collaring) between the top and bottom coils and the measured a_1 . One can conclude from Fig. 4 that the storage time between curing to collaring played a role.

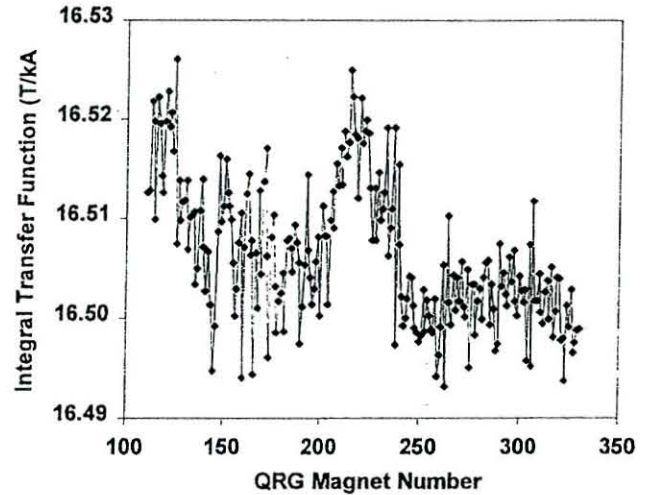
Figure 5: The measured integral transfer function with the magnet number in RHIC 80 mm aperture quadrupoles.

A pattern of variation was observed in the integral transfer function of 1.1 m long (magnetic length) 80 mm aperture arc quadrupoles (see Fig. 5). A careful examination of coil mechanical parameters revealed a similar pattern in coil length. This was later traced to an incorrect method employed by the vendor's subcontractor in assembling coil end parts. This resulted in the large variations of the coil ends and hence the overall coil length. Fig. 6 shows a correlation between coil length and integral transfer function. The assembly method was later corrected and the variations were reduced starting around magnet sequence number 240 in the magnets as shown in Fig. 5.

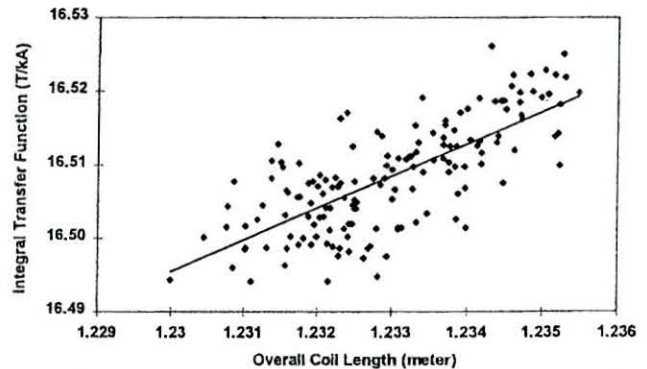
Figure 6: A correlation plot with a least square fit between the integral transfer function and the coil length in 80 mm aperture RHIC arc quadrupoles.

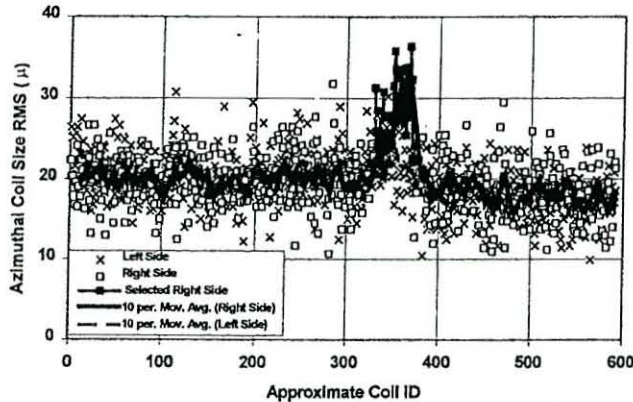
Figure 7: The standard deviation in the left and right azimuthal sizes of the RHIC arc dipole coils.

ining the harmonics carefully, the axial position, that was the source of this behavior, was located. The vendor was notified, who in turn reported overlapping curing shims in the press. This was corrected and the axial variation in the coil size (see Fig. 7), which had increased between approximate coil id numbers 320 to 370, returned to nominal values. The axial variations in harmonics also returned to their nominal values.

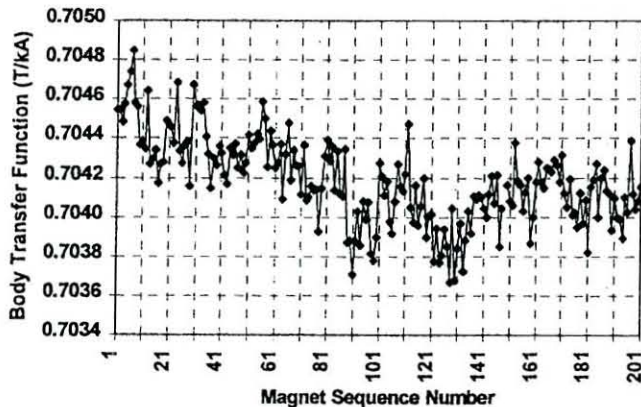
Figure 8: A trend plot of the transfer function in the body of the RHIC arc dipoles.

In 80 mm aperture RHIC arc dipole magnets, the collaring load at which the yoke midplane closure takes place is monitored [3]. This is related to the azimuthal pre-stress on the coil and it depends on coil sizes, yoke inner diameter and the size of the RX630 phenolic spacer between coil and yoke. During the production after magnet sequence number 89, a low value of yoke midplane closure pressure was observed. Simultaneously, a lower value of transfer function in the magnet body was also observed (see Fig. 8). The two were correlated and determined to be caused by a change in RX630 insulator thickness, stemming from an unapproved change to the mold by the vendor's subcontractor. The mold was corrected and the problem was fixed starting with magnet number 137. Due to scheduling issues, parts from the existing inventory were used between magnet number 108 to 136 after inspection.

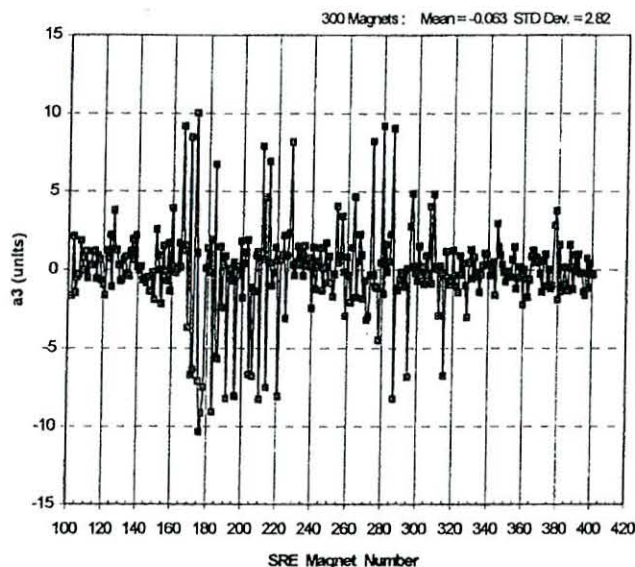
Figure 9: The measured skew octupole harmonic with the magnet sequence number in RHIC arc sextupoles.

The skew octupole term (a_3) in the sextupole magnets is an indicator of the top-bottom asymmetry. In the case of the RHIC sextupoles, the mean value of a_3 is zero by design and the measured value for most magnets lies within ± 2 units. Several magnets in the production, when measured warm, were found to have a_3 between 5 to 10 units, which is well outside the normal range (see Fig. 9). Nothing unusual was found in the geometric or electrical parameters of the coils in these magnets. Moreover, cold tests of some of these sextu-

poles revealed that the a_3 became quite small in the expected range of operation and practically disappeared at high fields. The large a_3 was later traced to the use of iron from two different heats for the upper and the lower yoke halves. The low field permeability value of the yoke in one particular heat was quite different from others. This explains the large measured value of a_3 harmonic only at very low fields. The sign of a_3 also correlated with whether the upper or the lower yoke half was from this heat. A value of 5 to 10 units is not of concern from the point of view of accelerator performance, however, the procedure shows the strength of the field quality as a technique to detect the deviations in the parts used in manufacturing magnets.
